November 14, 2014

RE: Cooper Site Building
350 Downie Street, Stratford, ON
Roofing Components - Visual Review

RJC No.: TOR.103282.0008

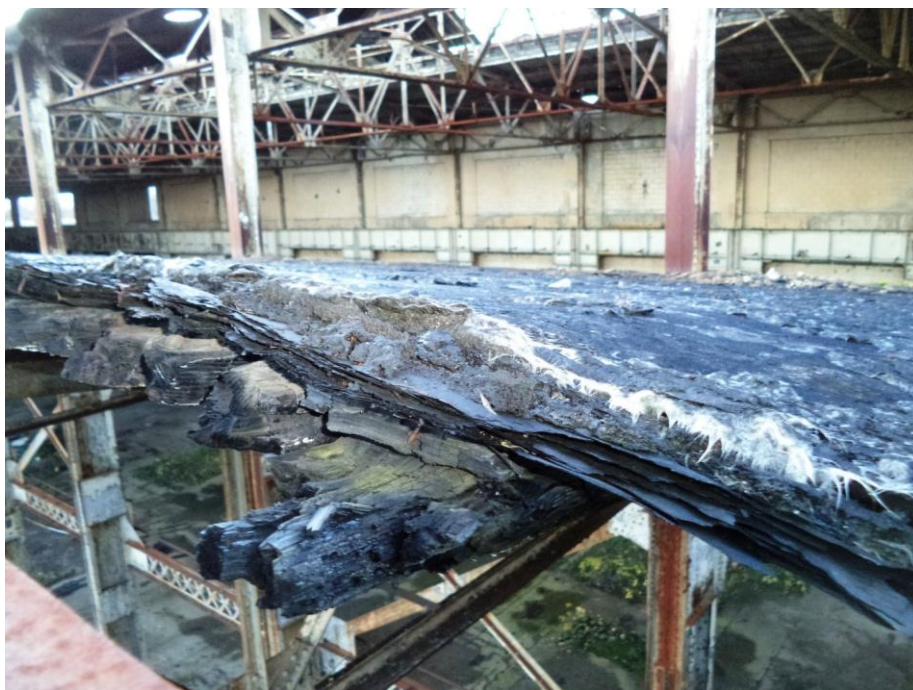
Photo #4: Typical Roof Deterioration

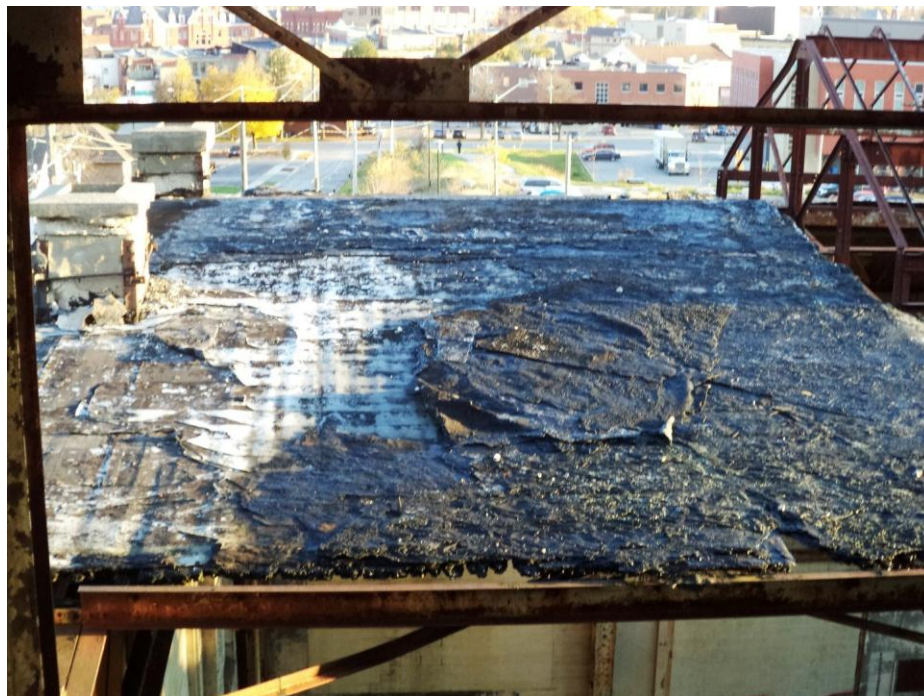
Photo #6: Typical Roof Deterioration
